**Orion Pulp Mill, Uruguay  
Independent Performance Monitoring  
as required by the  
International Finance Corporation**

**Environmental Performance Review  
2009 Monitoring Year**

Prepared by:  
**EcoMetrix**  
INCORPORATED

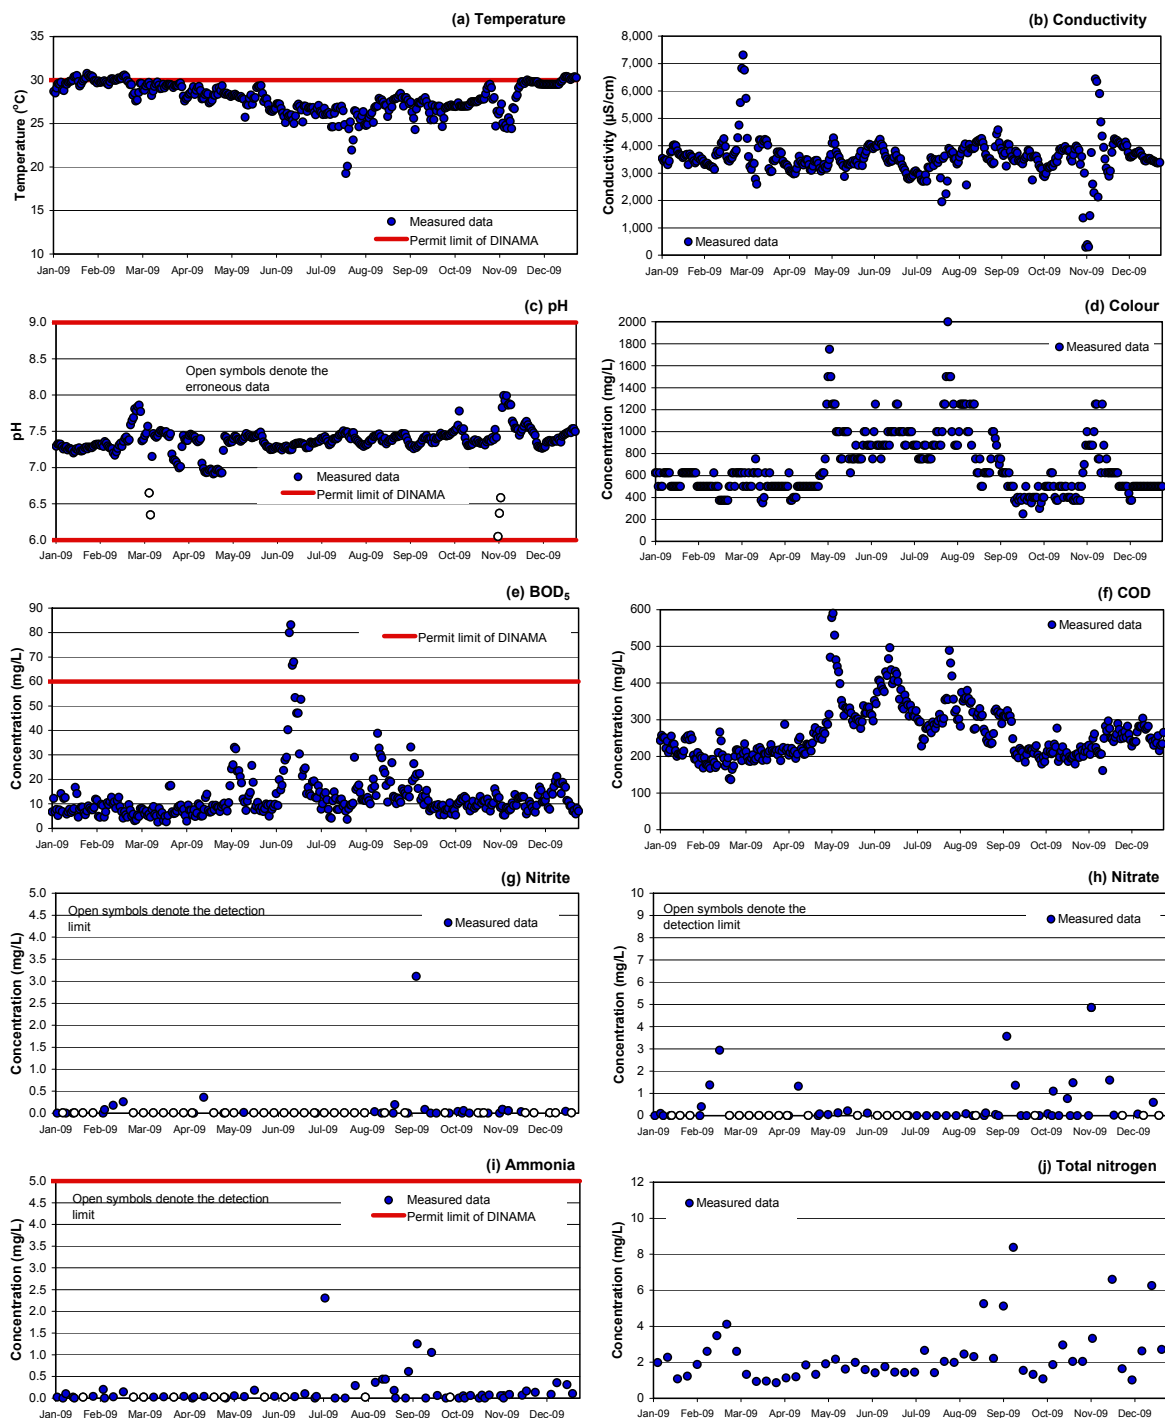
Figure 3.2: Effluent Monitoring Data – Discharge Quality<sup>1</sup>

The BOD<sub>5</sub> of the mill effluent averaged 13 mg/L, although the concentration exceeded the daily maximum permit limit of 60 mg/L during four days in June 2009. A report was issued to DINAMA outlining the cause of these events and mitigation steps that have been taken to restore the level of treatment previously achieved. These exceedances are attributed to elevated influent loadings from brown stock washing. The exceedances occurred over four consecutive days because the test procedure for BOD<sub>5</sub> requires a timeframe of five days to complete. Corrective measures were implemented as soon as the first exceedance was identified. The mill has since implemented an alarm system based on instantaneous turbidity measures to enable early detection of and rapid response to elevated influent loadings. The mill has also implemented improved procedures for washing the Drum Displacer-washers in order to reduce the influent loadings from brown stock washing.

<sup>1</sup> Permit limit of DINAMA – allowable maximum concentration from DINAMA (Autorización de Desagüe Industrial, 4<sup>th</sup> July 2007)

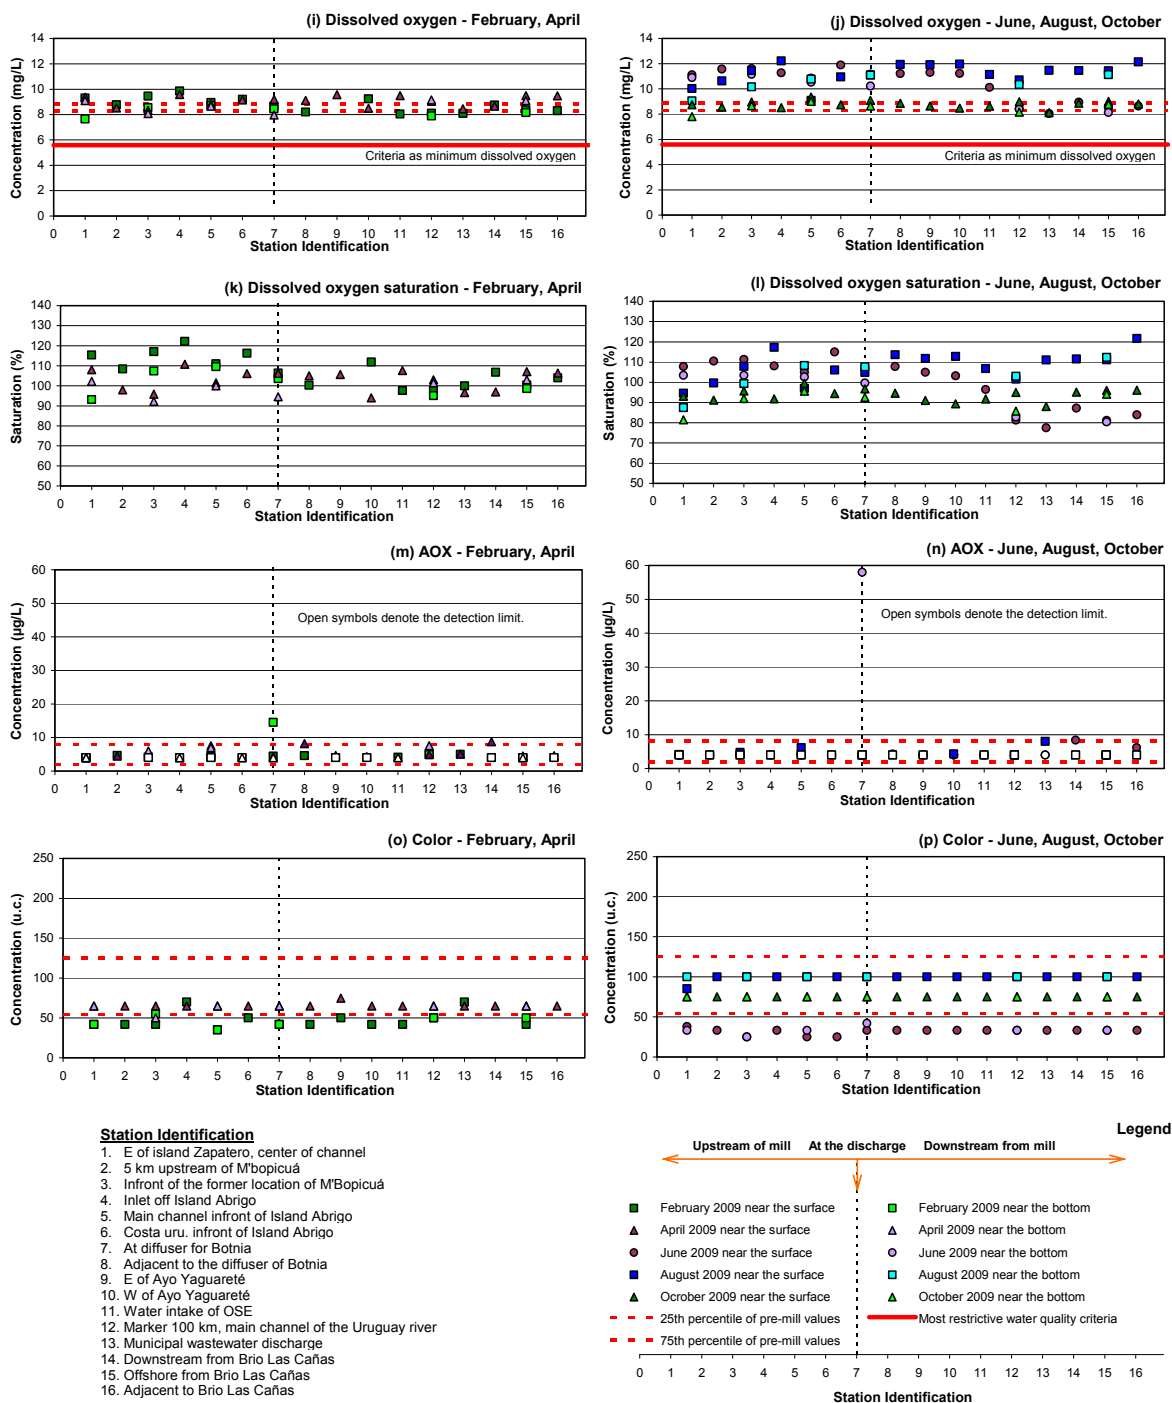
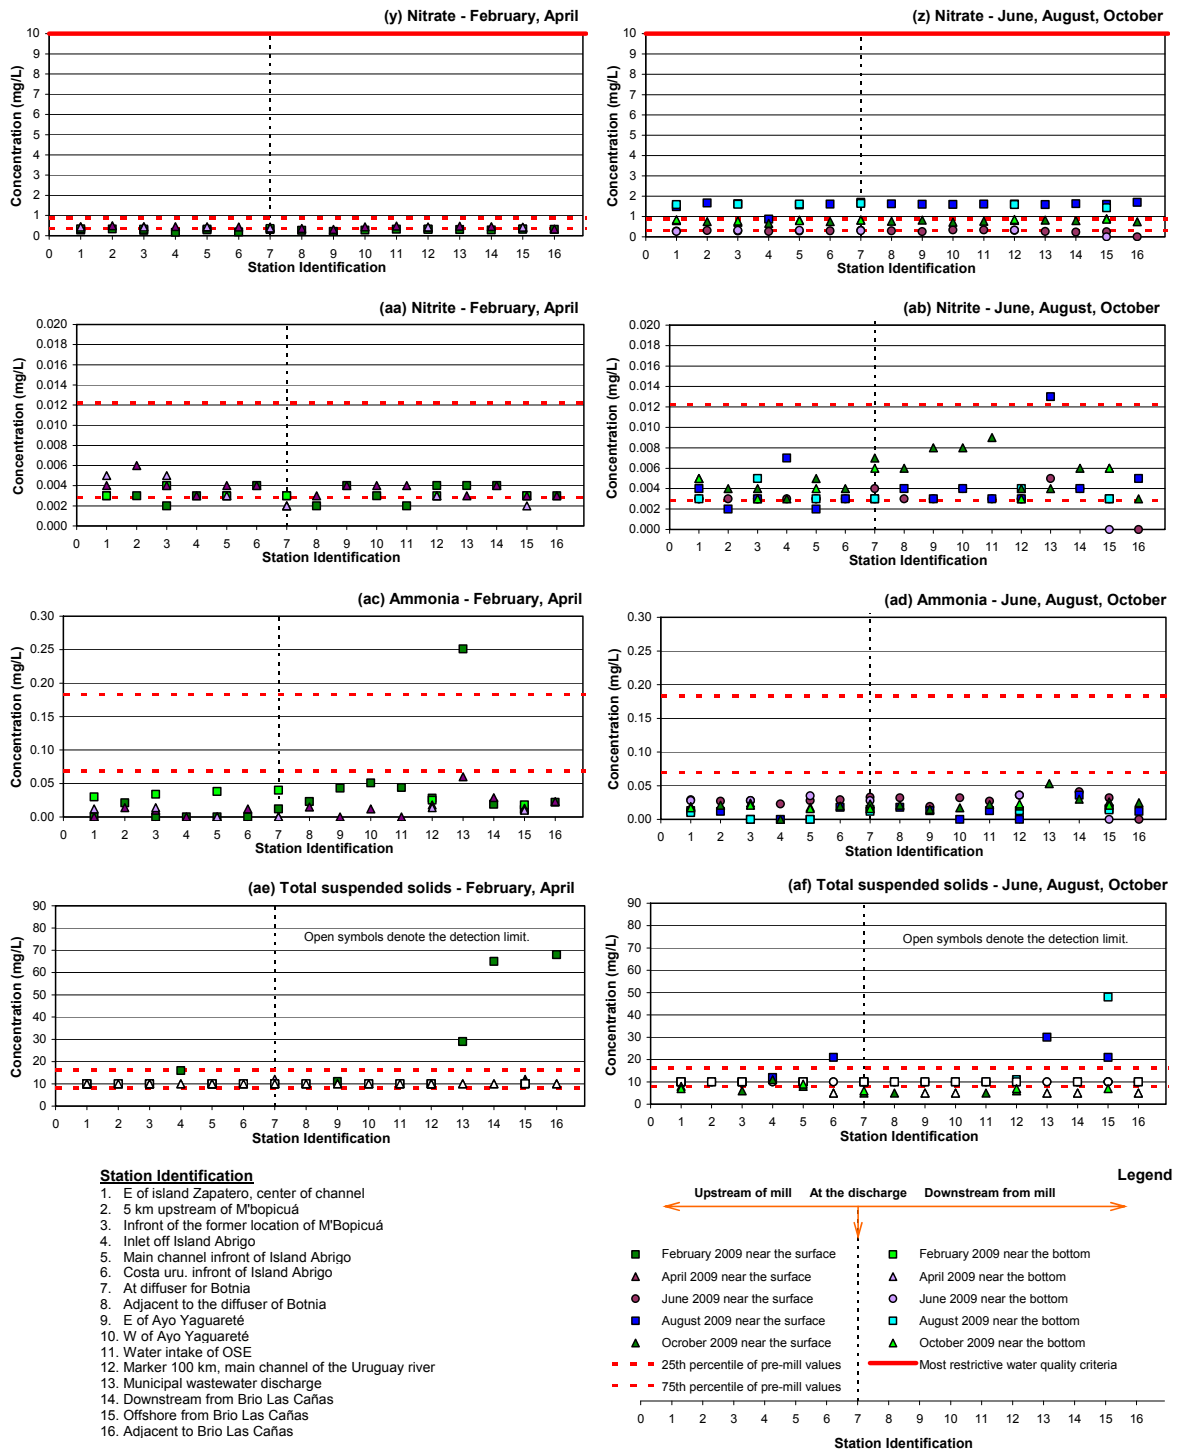
Figure 4.2: Water Quality Monitoring Data, Río Uruguay

- The water quality of the Río Uruguay is considered to be of high quality since the concentrations of indicator parameters are well below the most restrictive of the applicable Uruguayan and CARU standards. These parameters include: pH, dissolved oxygen, BOD<sub>5</sub>, nitrate, turbidity, fluoride, chloride, sulfate, R.A.S., cyanide, arsenic, boron, copper, chromium, mercury, nickel, zinc, and total phenols. As noted in the CIS, exceptions include bacteria, total phosphorus and iron, which exceeded the most restrictive standard prior to commissioning of the mill due to natural and anthropogenic sources throughout the watershed.

- The water quality between the mill and Fray Bentos is comparable to the water quality further upstream beyond the influence of the mill indicating that the mill has not affected water quality within the Río Uruguay.
- The CIS concluded that the water quality within the Río Uruguay would remain in compliance with surface water quality standards of DINAMA and CARU (with the noted exception of total phosphorus due to its high baseline concentration due to natural and anthropogenic sources throughout the watershed); and that trace levels of wastewater from the mill would not adversely affect water quality. The water quality monitoring results from DINAMA confirm these conclusions.

Bacteria levels (fecal coliform, enterococcos and E. coli) are below the most restrictive standard (i.e., CARU, Use 2, Recreation) at most monitoring stations during most surveys. The standard is routinely exceeded at the monitoring station located near the municipal discharge for the City of Fray Bentos (Station 13) and has been exceeded during one or more surveys across the waterfront of Fray Bentos and Las Cañas. These elevated levels are attributed to sources of bacteria from within the urban areas of the city, and are not attributed to the mill effluent since the observed levels within the Río Uruguay far exceed the levels measured in the treated mill effluent, particularly during the summer low flow surveys in February and April 2009.

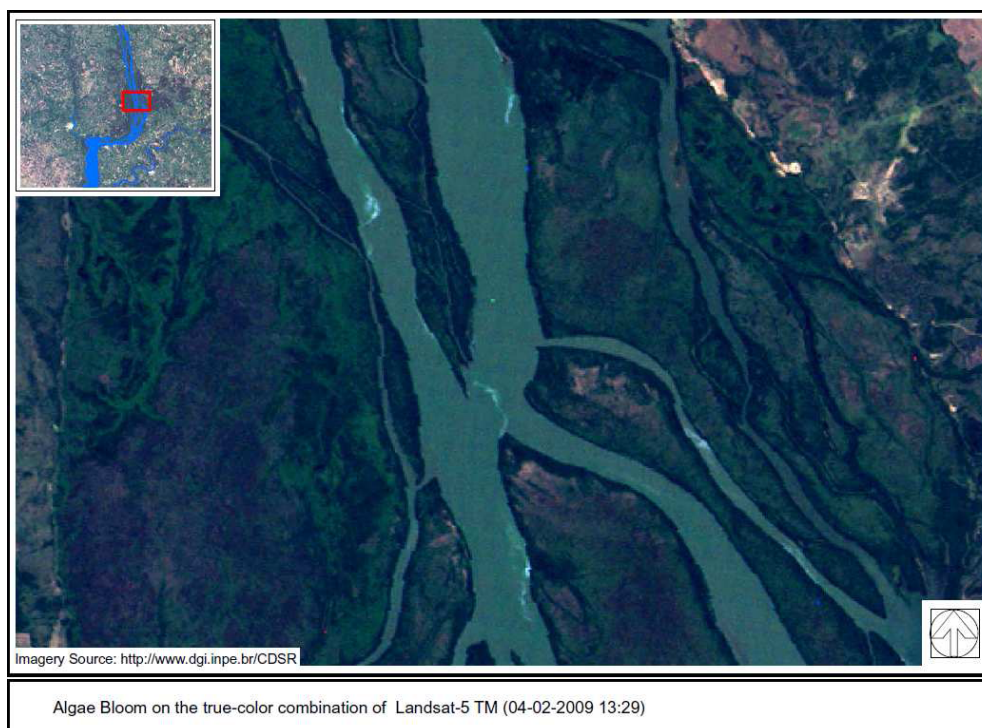
**Figure 6.2** Close up of the upper extent of the bloom on 4 February 2009

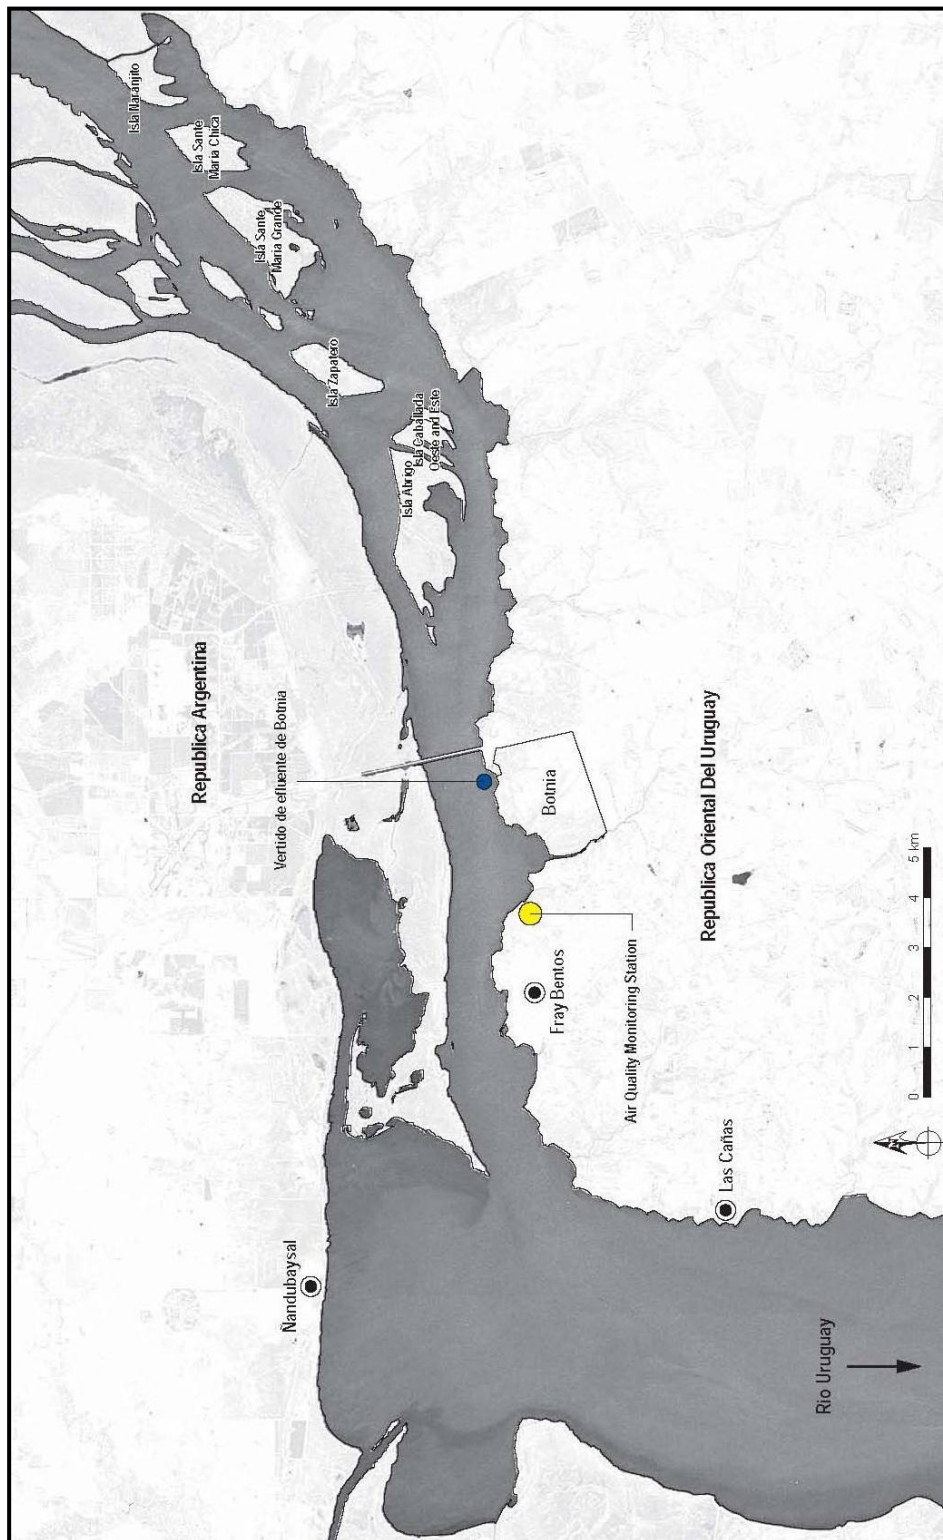
**Figure 8.1: Air Quality Monitoring Station**

Air quality is measured by LATU at a monitoring station located between Fray Bentos and the mill (Figure 8.1). Parameters routinely monitored include CO, NO<sub>x</sub>, SO<sub>2</sub>, TRS, PM<sub>10</sub> and TSP. The available data for the 2009 monitoring year are presented in Figure 8.2.
